RULES AND REGULATIONS

The following policies and rules, which require modifications of aircraft for the purpose of remedying defects affecting airworthiness, are hereby adopted. They shall become effective upon publication in the **FEDERAL REGISTER** unless otherwise indicated, in order to promote safety of the flying public. Compliance with the notice, procedures, and effective date provisions of section 4 of the Administrative Procedure Act would be impracticable and contrary to the public interest and, therefore is not required.

1. *Introduction to airworthiness directives (CAA policies)*—(a) *General.* (1) The Civil Aeronautics Act of 1938, as amended, empowers the Administrator of Civil Aeronautics to issue type certificates for aircraft after he determines that the aircraft is of proper design, material, specification, construction, and performance for safe operation, and that it meets the minimum standards prescribed by the Board. If the Administrator finds that the aircraft conforms to the type certificate therefor, and, after inspection, that the aircraft is in a condition for safe operation, upon application by the registered owner, he will issue an airworthiness certif

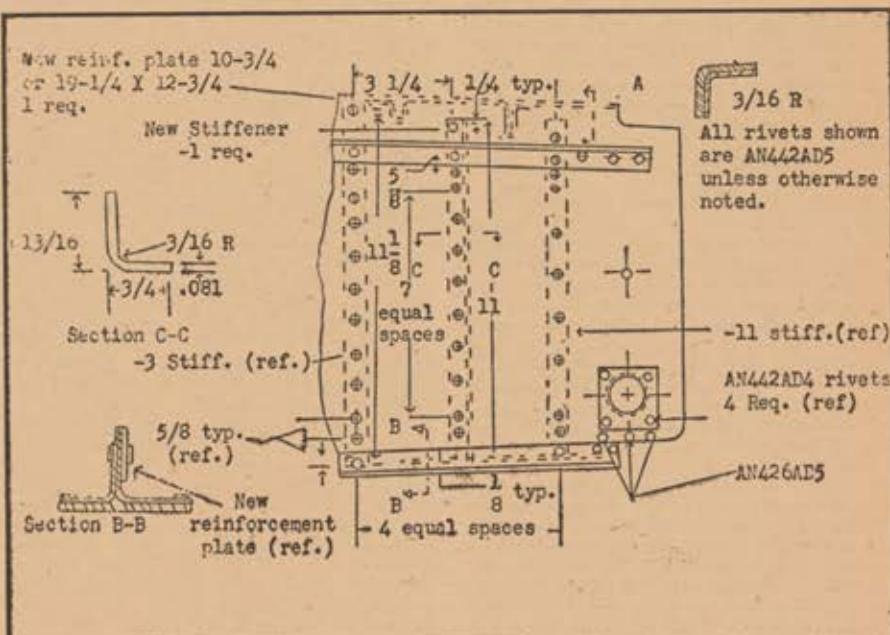
FIGURE 1.

a. The rear spar in the region of the aileron hinge brackets.

b. The upper and lower corners of the intermediate ribs, which support the aileron

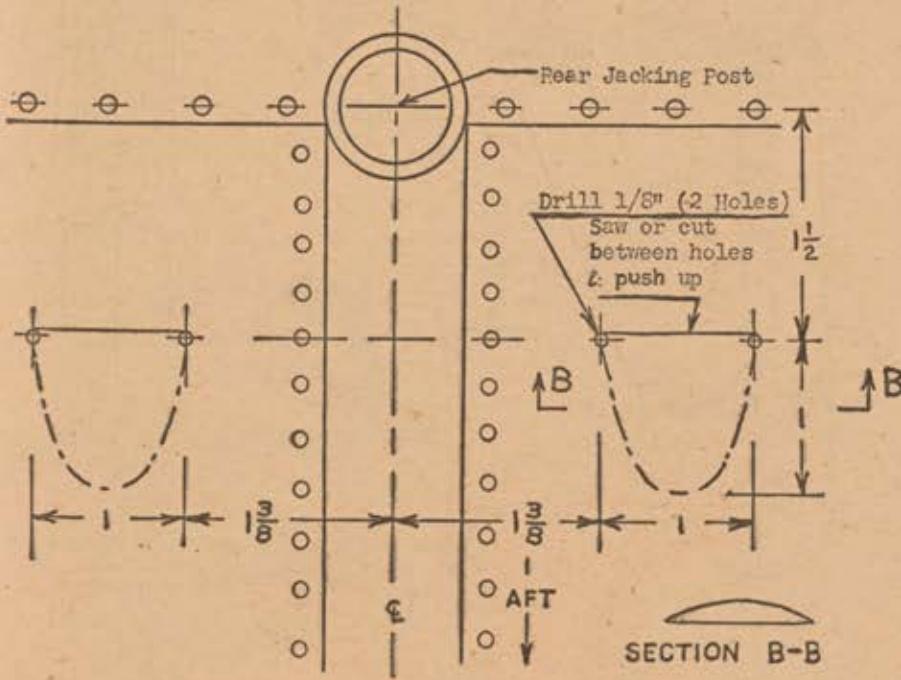
FIGURE 3.

47-34-2 BEECH (Was Mandatory Note 3 of AD-770-1 and Mandatory Note 4 of AD-765-1.) (Applies to airplanes which do not have drain provisions at bulkhead No. 15.)

Compliance required prior to December 1, 1947. To provide additional drainage, to prevent freezing of trapped moisture in the tail cone which could jam the elevator control system, a $\frac{1}{4}$ -inch diameter hole should be drilled near the front of the tail cone
