FEDERAL REGISTER

Washington, Tuesday, December 4, 1956

TITLE 14—CIVIL AVIATION

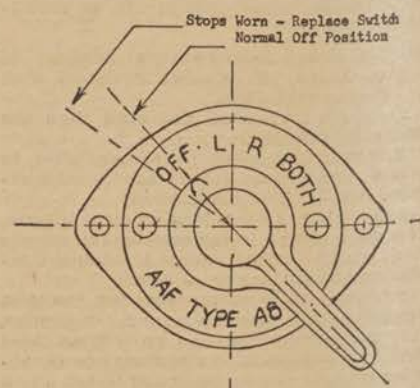
FIGURE 12.

position. The pointer projecting from the lever points to the middle "F" in the word "OFF." When the lever can be turned to a point beyond the centerline of the "O" in the word "OFF," the rotation stops have become worn and the switch should be replaced.

1. Inspection should consist of the following: Check switch lever for overtravel past the "off" position. The sketch below shows the location of the switch lever in the "off"

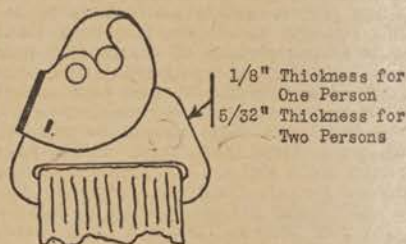
Care should be taken not to confuse these fittings with another Warren McArthur fitting P/N 13971 (also known as P/N 314-AS12) which is identical in appearance except that the fitting plate thickness is 5/32 inch.

WARREN MCARTHUR FITTING No. 275-AS26
FIGURE 13

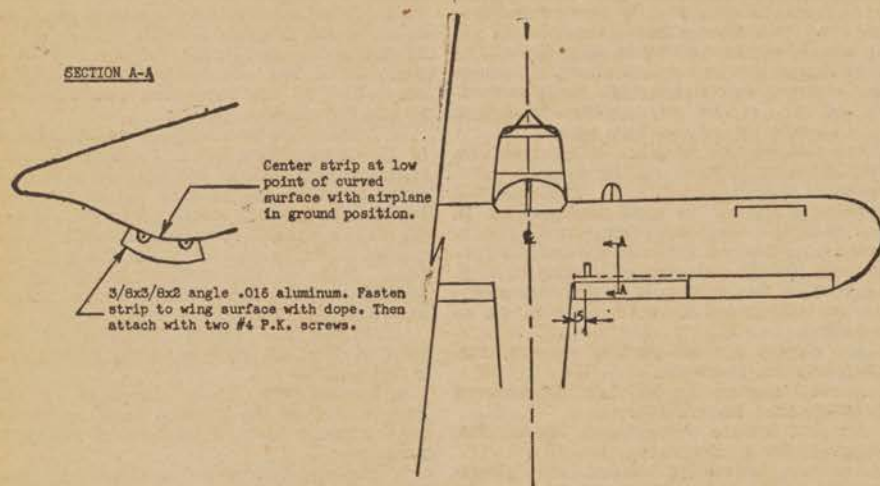
FIGURE 14.

To preclude the fire hazard of fuel soaked insulation within the cabin wall due to these causes, a drip strip similar to that shown in the accompanying sketch should

be installed on the underside of each wing. This drip strip will prevent fuel from flowing from the wing to the fuselage. (Piper Service Bulletin No. 115, dated March 31, 1950 covers this same subject.)

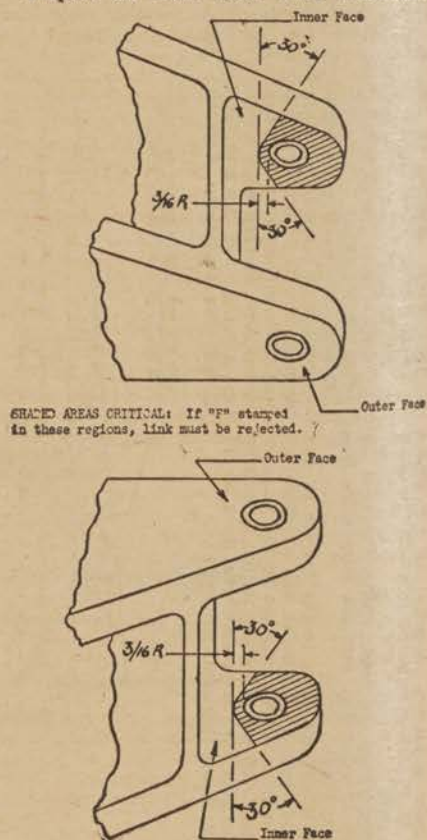
FIGURE 19.

(P/N S510348) received from the manufacturer between June 1 and September 6 inclusive for location of the identification stamp "F". Links with the "F" metal-stamped in the critical area on the inner faces of the ears should be retired from service. Those with the "F" stamped on the outer faces or on non-critical areas of the inner faces of the ears should be polished locally with emery and crocus cloth to remove the "F" and the links may be returned to service. (Sikorsky Information Circular Number 175, dated September 7, 1951, covers this same subject.)

1. Compliance required prior to next flight. Inspect all main rotor Link Assemblies

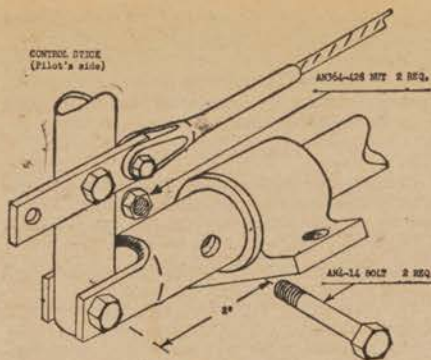
FIGURE 22.

As a result of a reported failure of the welded joint in the elevator control tube socket, the following, or equivalent, should be accomplished, to preclude the possibility of recurrence of this type failure:

(a) Install a 1/4-inch AN steel bolt through the elevator control tube socket as shown below and secure with an elastic stop nut. Two installations will be necessary, one on the Pilot's side and one on the Passenger's.

(b) Due to the limited amount of clearance, it is recommended that the bolts be installed in the direction and location as shown. Ascertain that adequate clearance is provided when the control stick is operated throughout its full range.

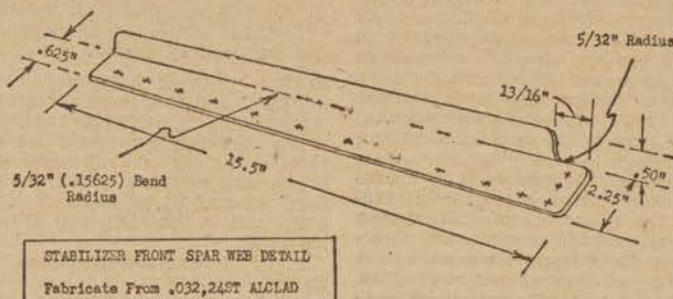
FIGURE 27.

Inspect as soon as practical, but not later than February 1, 1953, and at 100 hour intervals thereafter the area in the vicinity of the stabilizer fuselage attachment for cracks. Particular attention should be given to the stabilizer spar web (gusset) immediately outboard of the root rib and the fuselage attaching fitting. If cracks are found in the fuselage fitting, P/N 143-31004-13, the entire part should be replaced. Cracks in the root rib may be repaired in accordance with CAM # 18. Cracks in the spar web (gusset) require the replacement of the gusset with a new part made in accordance with the following sketch.

Periodic inspections of stabilizer spar web only may be discontinued after installation of new gussets. (Ryan Navion Field Service Bulletin # 17 dated September 26, 1952, covers this same subject.)
