DEPARTMENT OF TRANSPORTATION

Federal Aviation Administration

14 CFR Part 39

Airworthiness Directives; Enstrom Helicopter Model F-28A, F-28C, F-28C-2, F-28F, 280, 280C, and 280F Series Helicopters

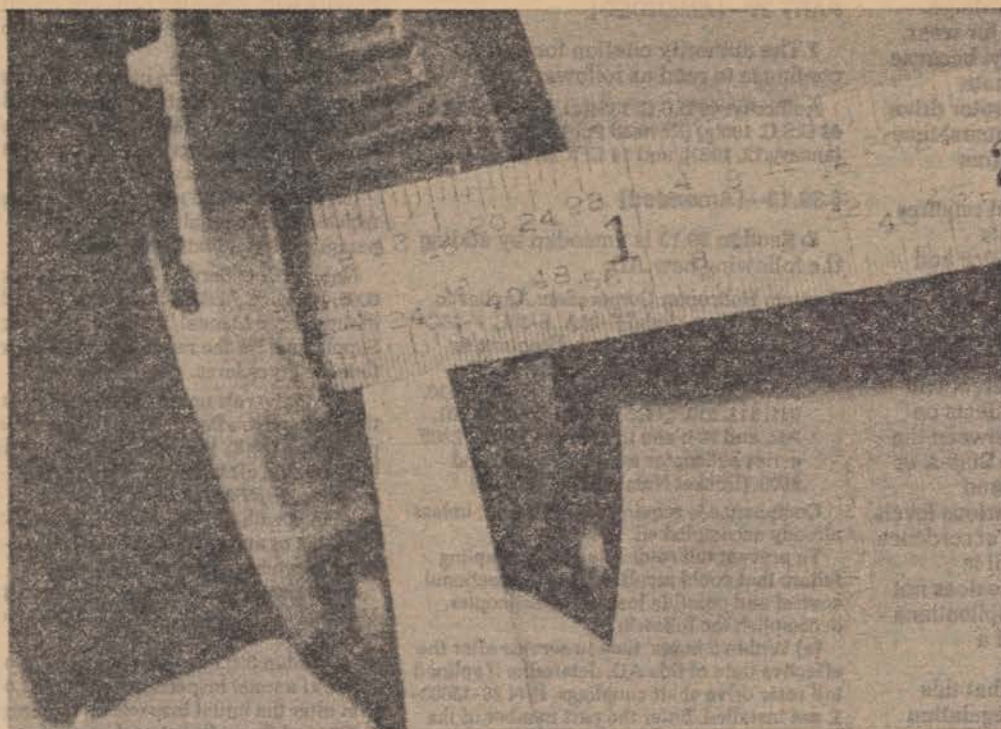
(i) Visually and dimensionally inspect for wear and proper tooth contact in accordance with Figure 1. Measure the height of the spline crown shown in Figure 2 at the center with a steel scale (having graduations of 1/100 inch) and a 10 power glass. Replace with airworthy parts and couplings that have a center crown height of less than 0.015 inch.

Figure 1. Checking inner spline wear on coupling.

NOTE: Tooth wear is measured by placing a 6 inch steel rule parallel to the crown at the top edge of the driven side. A piece of .125 x .010 inch shim stock is then placed between the tooth and the rule, and pressing the rule against the tooth, check if the shim can be removed. If the shim slips out, the coupling is to be rejected and replaced with an airworthy component.

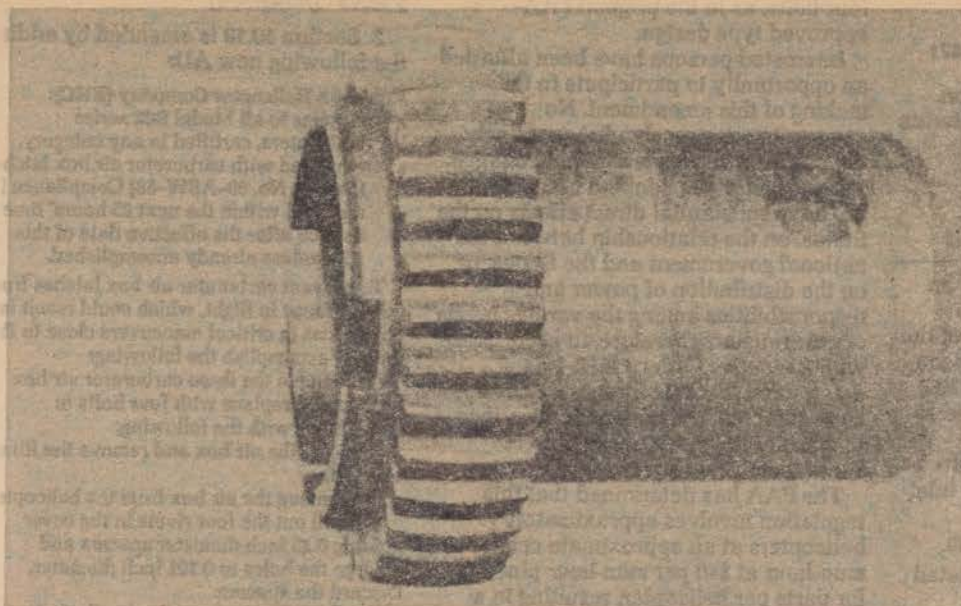
Figure 2. Checking outer spline wear on male coupling.

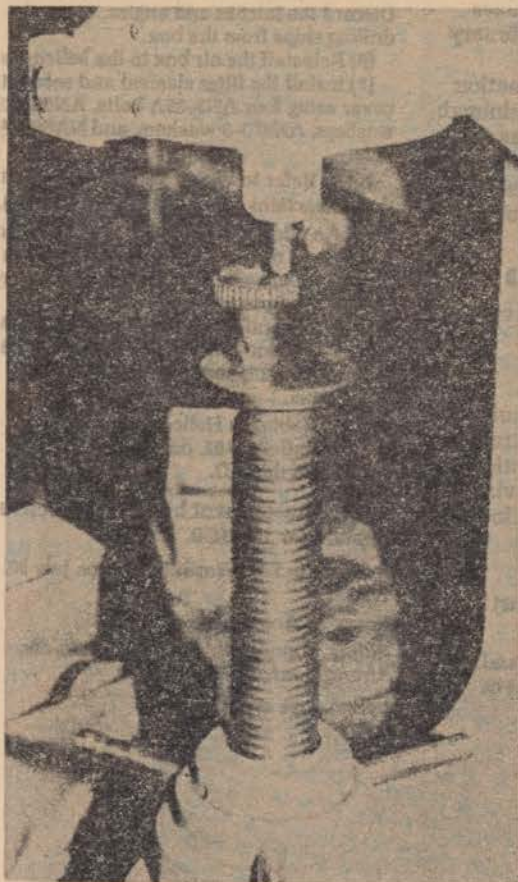
(ii) Test both the male and female portions of the coupling for material hardness. Test the male portion on the inner circular face as shown in Figure 3. Test the end of the stud of the female portion as shown in Figure 4. Use three readings and average the readings.

Figure 3.
Checking hardness on male
portion of coupling.

Replace with airworthy parts any couplings which have average readings below 25 on the Rockwell "C" scale.

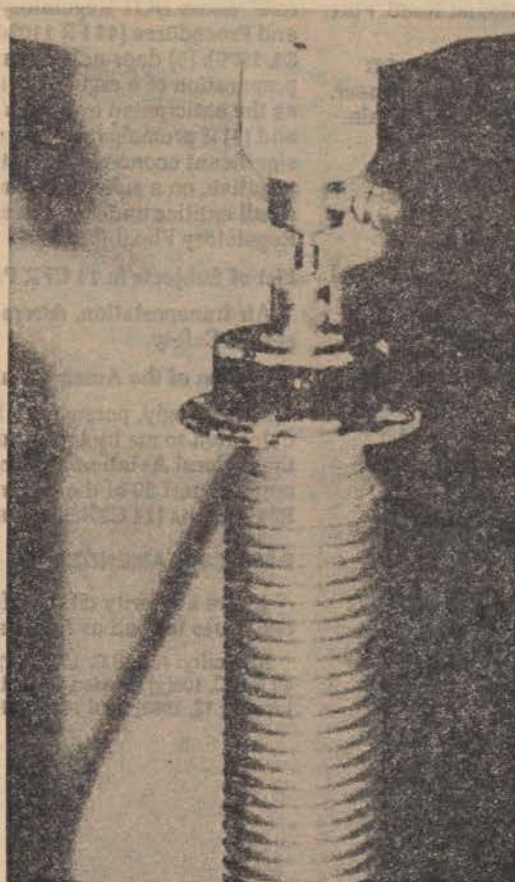
Figure 4.
Checking hardness on female
portion of coupling.

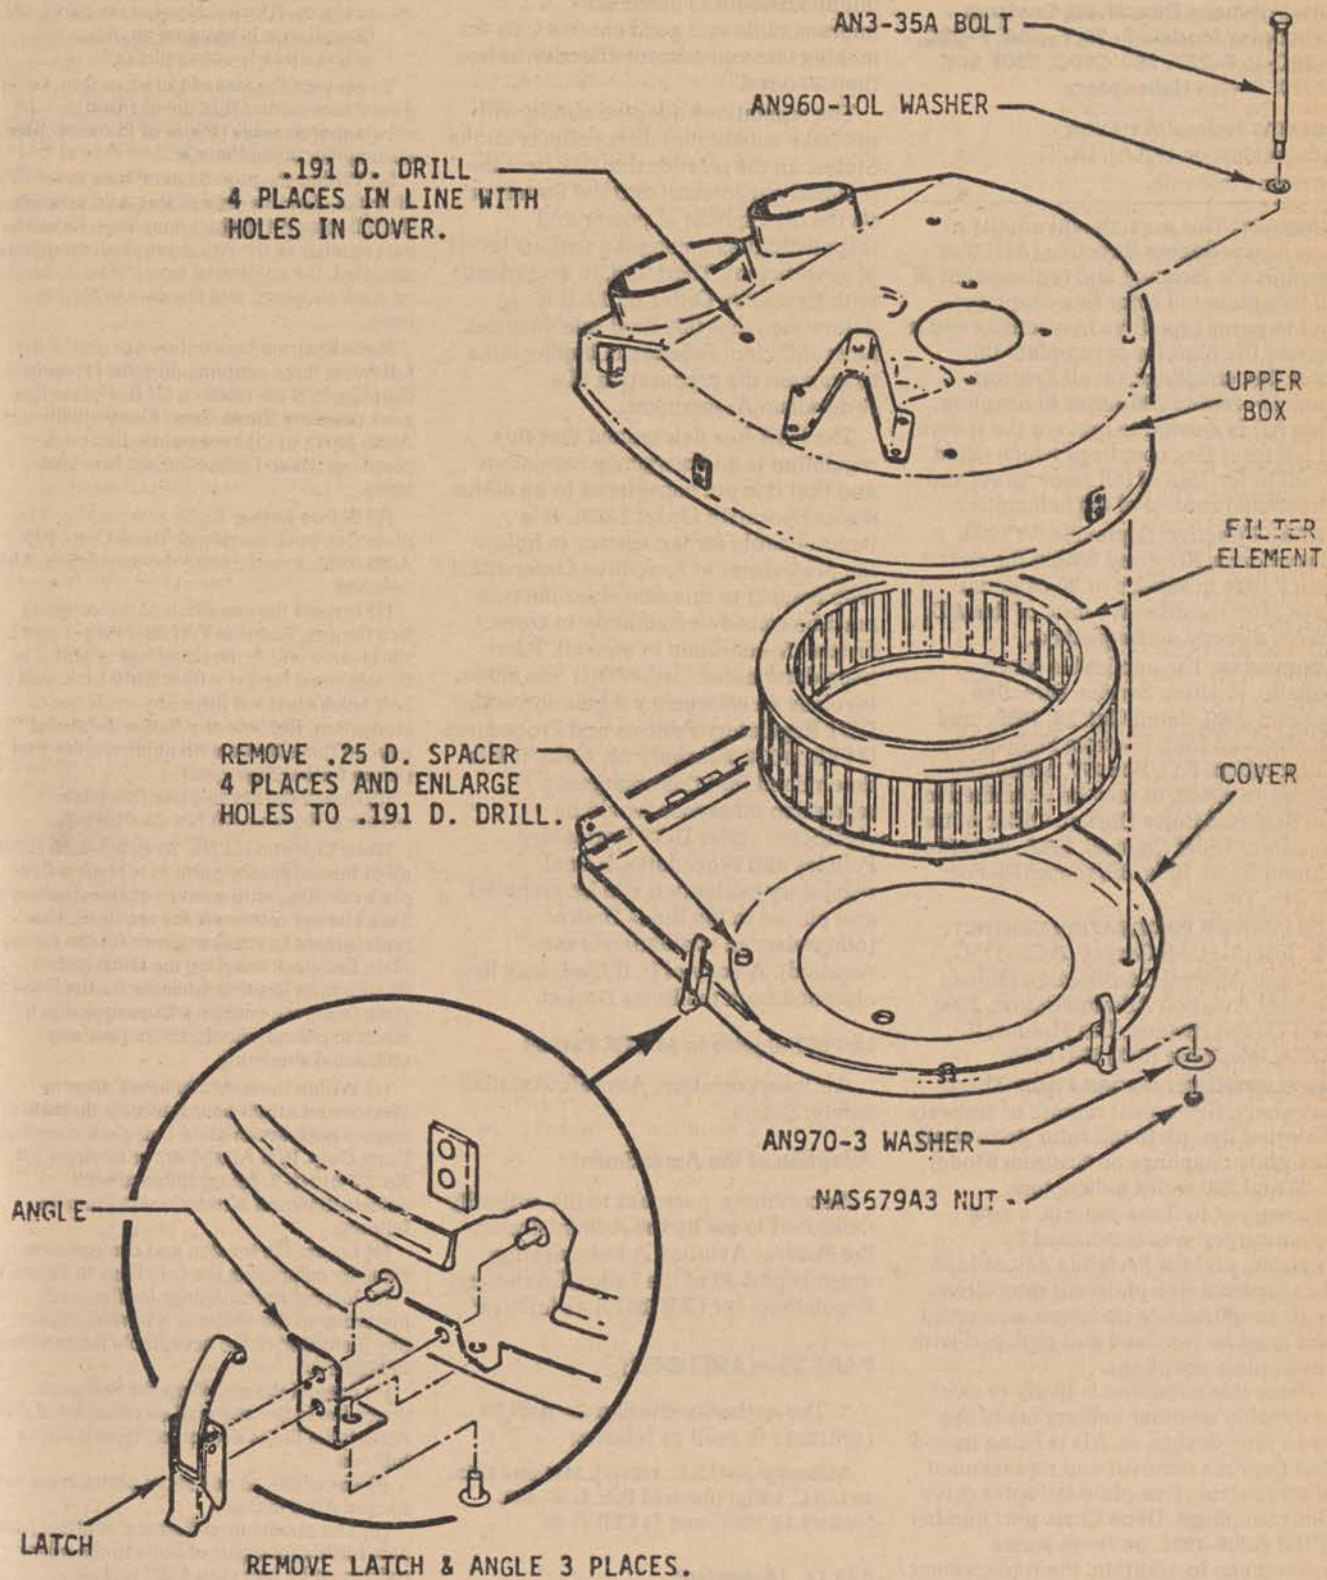
FIGURE 1

The proposal was prompted by reports of carburetor air box latches coming loose in flight and allowing the air filter to become dislodged which could cause loss of engine power and subsequent loss of the helicopter. RHC issued Service Bulletin No. 61, dated July 28, 1989, that provides instructions for removing the three carburetor air box latches and replacing them with

- (a) Remove the three carburetor air box latches and replace with four bolts in accordance with the following:
 - (1) Open the air box and remove the filter element.
 - (2) Remove the air box from the helicopter.
 - (3) Drill out the four rivets in the cover holding 0.25 inch diameter spacers and enlarge the holes to 0.191 inch diameter. Discard the spacers.
 - (4) Close the cover, and using the holes in the cover as guides, drill four matching holes through the upper box in line with the holes in the cover.
 - (5) Open the air box and drill out all the rivets holding the latches to the cover. Discard the latches and angles. Clean the drilling chips from the box.
 - (6) Reinstall the air box to the helicopter.
 - (7) Install the filter element and secure the cover using four AN3-35A bolts, AN960-10L washers, AN970-3 washers, and NAS679A3 nuts.

Note: Refer to Figure 1 for accomplishing the instructions required by paragraph (a).
