#### Title 14—Aeronautics and Space

[Docket No. 76-EA-100; Amdt. 39-2891]

## PART 39—AIRWORTHINESS DIRECTIVES

### Piper Aircraft

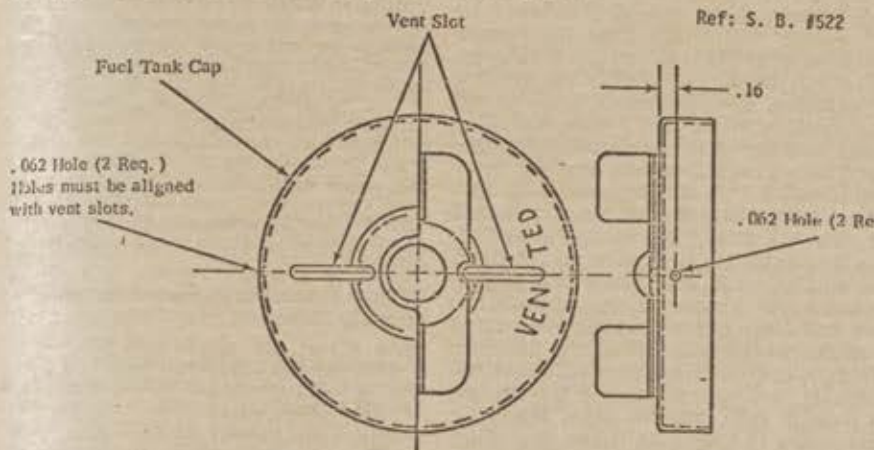
VIEW OF FUEL TANK CAP - P/N 15296-02

In order to prevent fuel starvation due to obstructed venting around the fuel tank filler cap, accomplished the following:

a. On those aircraft incorporating P/N 15296-02 fuel filler caps which were made available in June 1976, remove each cap from

the wing tanks and alter the caps by drilling two .062" diameter holes 180° apart on the outer edge surface .16" down from the top of the cap. Holes must be aligned with vent slots as shown. Accomplish this alteration on all P/N 15296-02 filler caps or replace these caps with original vented caps and gaskets as listed in the appropriate Piper parts catalog.

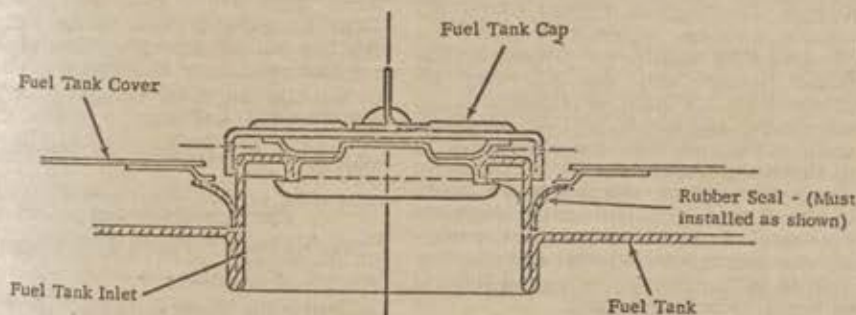
CROSS SECTION OF FUEL TANK INLET AND RUBBER SEAL

SUPPLEMENTARY INFORMATION: There have been reports of fuel tank collapse and fuel starvation because of improper installation of the tank filler neck rubber seal. The directive requires drilling two holes which will insure positive venting even though other vent passages may be blocked.

b. Inspect the rubber seal around the fuel tank inlet filler neck to determine if seal was installed inverted or is properly installed as shown. If seal is not installed correctly, remove the fuel tank cover from wing, reposition the seal as shown and reinstall fuel tank cover.
