RULES AND REGULATIONS

The following policies and rules, which require modifications of aircraft for the purpose of remedying defects affecting airworthiness, are hereby adopted. They shall become effective upon publication in the **FEDERAL REGISTER** unless otherwise indicated, in order to promote safety of the flying public. Compliance with the notice, procedures, and effective date provisions of section 4 of the Administrative Procedure Act would be impracticable and contrary to the public interest and, therefore is not required.

1. *Introduction to airworthiness directives (CAA policies)*—(a) *General.* (1) The Civil Aeronautics Act of 1938, as amended, empowers the Administrator of Civil Aeronautics to issue type certificates for aircraft after he determines that the aircraft is of proper design, material, specification, construction, and performance for safe operation, and that it meets the minimum standards prescribed by the Board. If the Administrator finds that the aircraft conforms to the type certificate therefor, and, after inspection, that the aircraft is in a condition for safe operation, upon application by the registered owner, he will issue an airworthiness certif

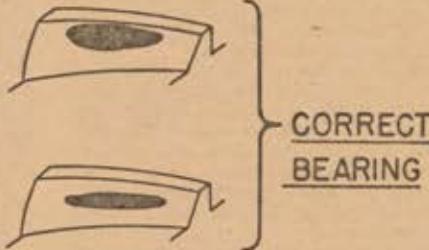
(l) After the power take-off has been fastened securely in place, the gear box must be operated by hand by turning the end of the pinion shaft protruding from the power take-off. After a few revolutions, remove the power take-off and check the tooth pattern. The correct tooth pattern is shown in figure 10. The necessary adjustment for proper tooth pattern and backlash should be accomplished by shimming with power take-off

PINION
(SAME ON BOTH SIDES)

GEAR
(SAME ON BOTH SIDES)
