FEDERAL REGISTER

Washington, Tuesday, December 4, 1956

TITLE 14—CIVIL AVIATION

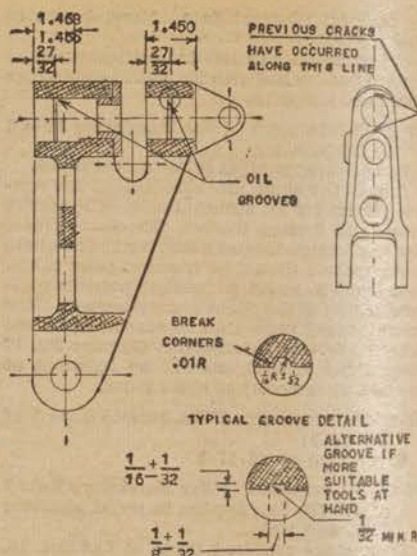
FIGURE 3.

2. Visually inspect main rotor links, part No. VS 36181 by one of the following methods for cracks around link pin hole and longitudinally along what was the flash line in original forging. (See Figure 3.) If cracks are present, links should be scrapped.

3. Machine oil grooves. (See Figure 3.)

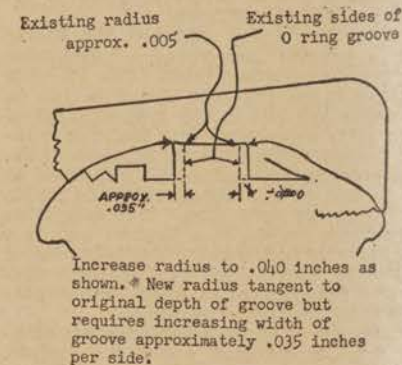
FIGURE 32.

Remove the landing gear retraction cylinder head and inspect the upper and lower radii of the O ring groove for cracks by means of a dye penetrant. If cracks are found the part should be replaced. In the event no cracks are present the upper and lower radii of the O ring groove should be increased to 0.040 inch as shown in the sketch below and again inspected by means of a dye penetrant. If no cracks are found after this inspection, the part may be returned to service; however, if cracks are evident, the part should be replaced.

NOTE: Smooth machine finish (RMS-32 or better) with no tool marks or discontinuities. No change in size of O ring necessary.
